Nokia Lumia 920 Back panel Replacement

Replace the back panel if: cracked, charging port is broken, panel is cracked.

Remove the back panel to access the internal components of your Nokia Lumia 920.

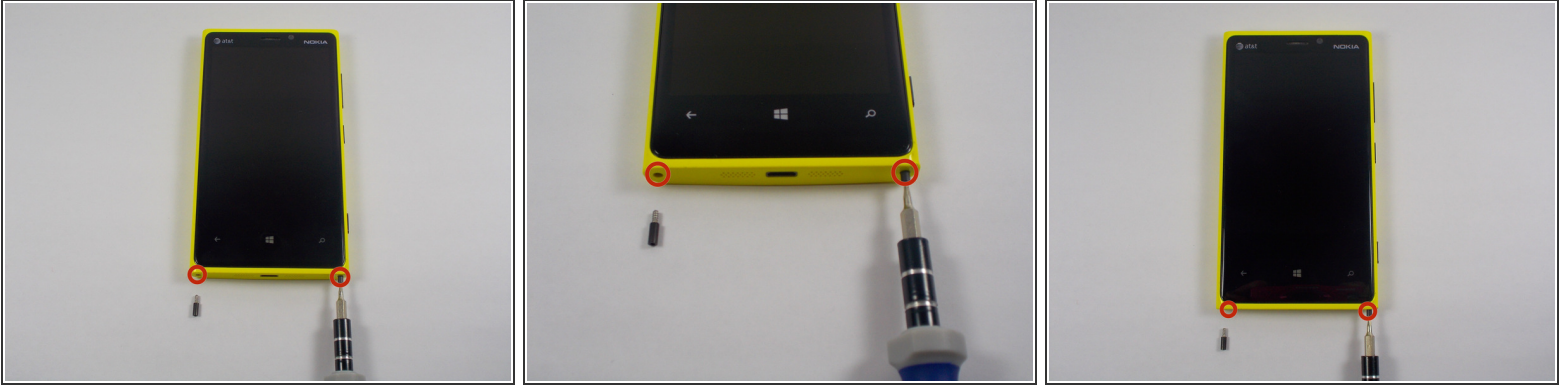
Step 1 — Remove the Bottom Screws

- Use the T5 screwdriver to remove the two 8.6mm long screws, located at the bottom of the phone. (Head size is 2.5mm)

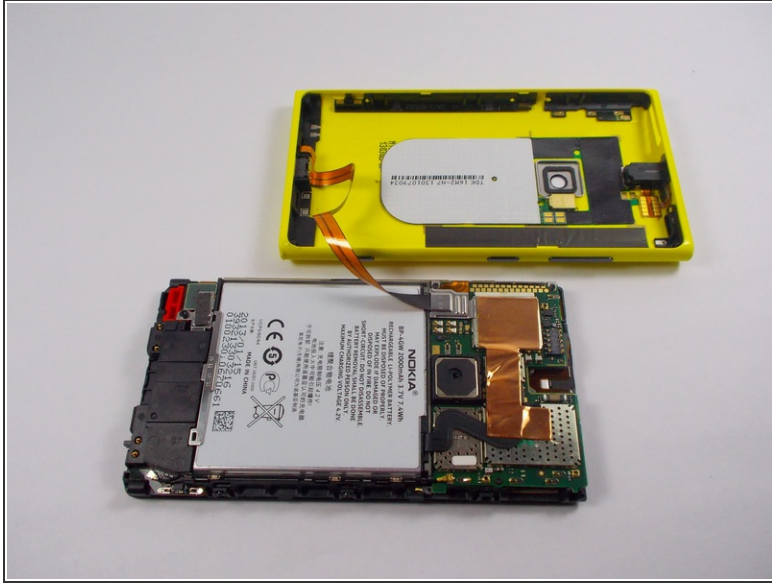
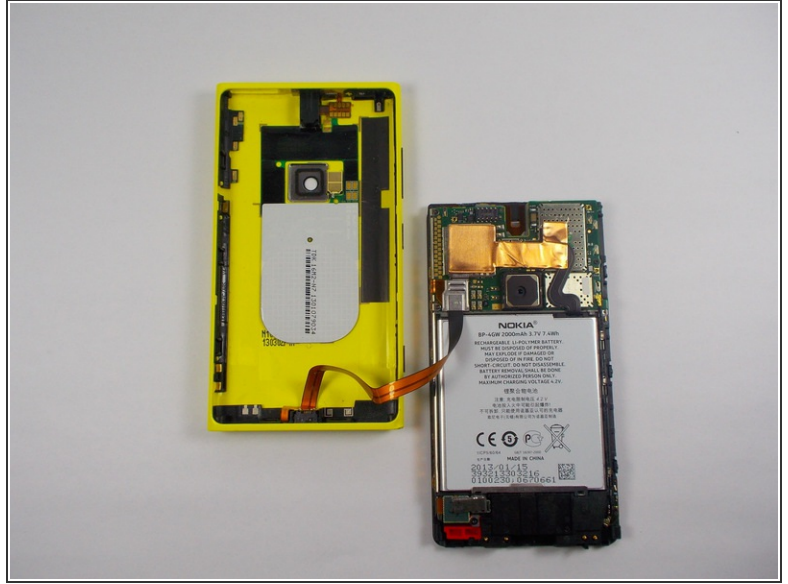
Step 3

- Once both screws on the bottom are removed, and the plastic SIM protective piece is removed, gently push on the outside of the screen.
- The screen should become separated using little force. And should like the pictures shown once complete.
